# HOW SAFE IS OUR SPACE?

A PUBLIC SPACE  
SAFETY AUDIT  
OF JOHOR BAHRU

SAFETYPLAN  
Supporting Safer Cities

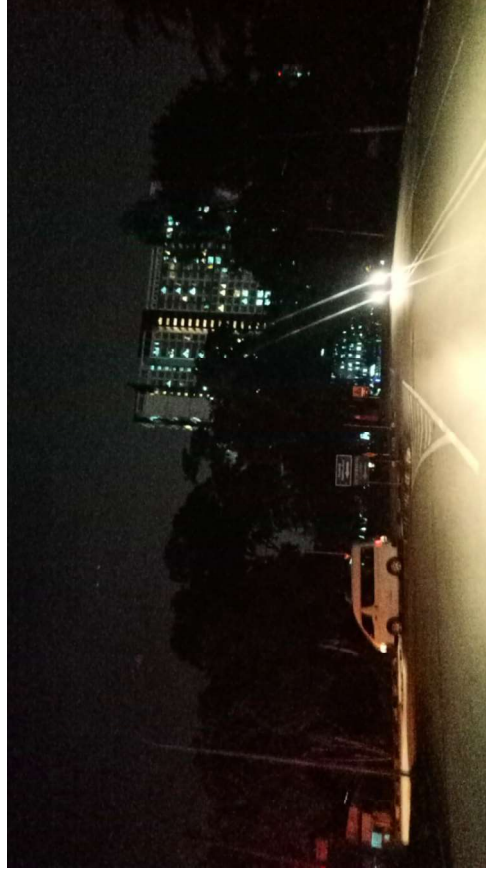
Image 4: Street with non-functional street lights, with only source of lighting coming from surrounding cars and buildings

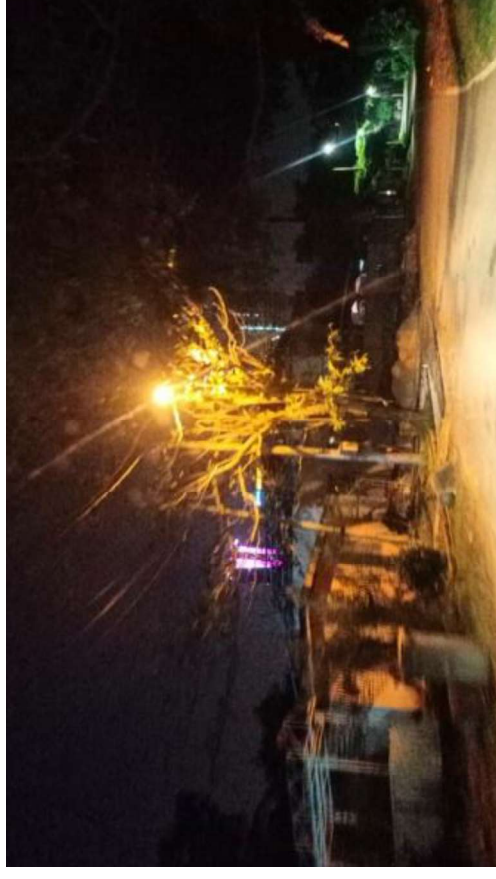
Image 6: Street with unpaved walk path

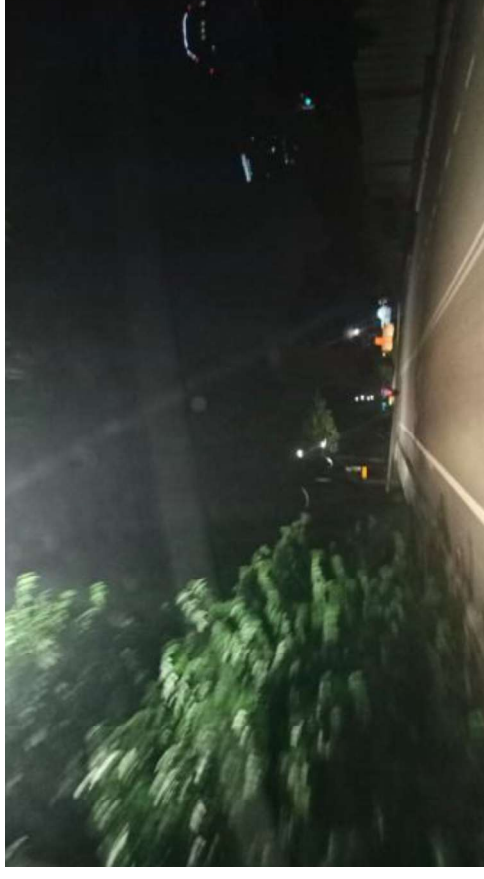
Image 8: Street with no natural surveillance and presence of 50% boundary walls

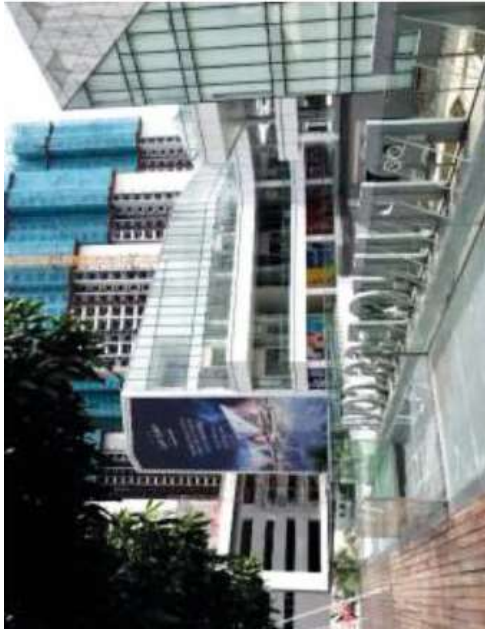
Image 12: One of the walk path to the Opera House. It was found to be dimly lit during night

Though the structure itself was lit, the surrounding area was not well-lit. The path to the Opera House was found to be dimly lit by shops and office buildings' lighting.

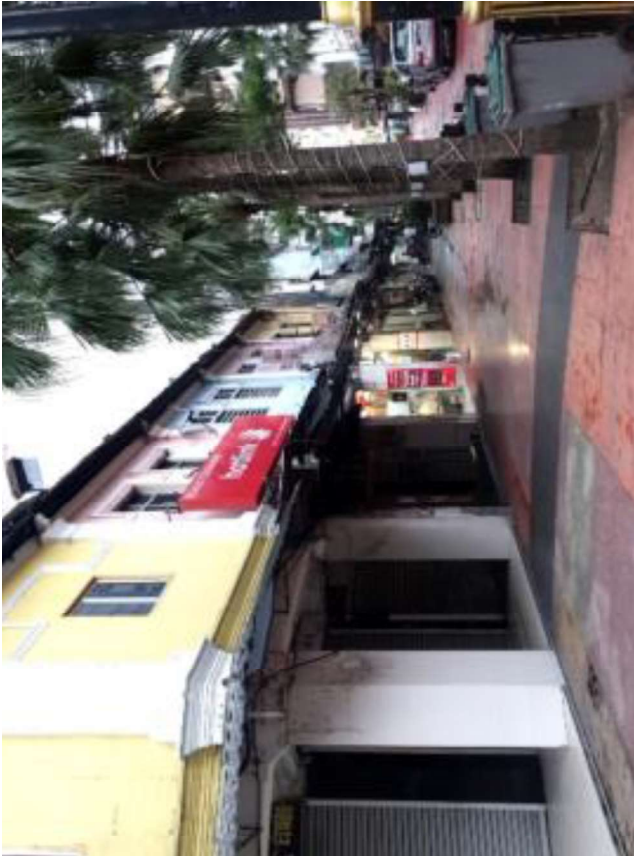
Image 19: The walk path was wide, paved and elevated from the main road

The walk path was paved and elevated from the main road as a divider for pedestrians. Bollards and fences were fitted at some stretches to avoid vehicular parking on the pedestrian path. The pavement was wide enough for wheelchair users but does not have curb ramps at the corner for smooth transitions. At a few points, the path was broken. Additionally, no pedestrian crossings were identified.

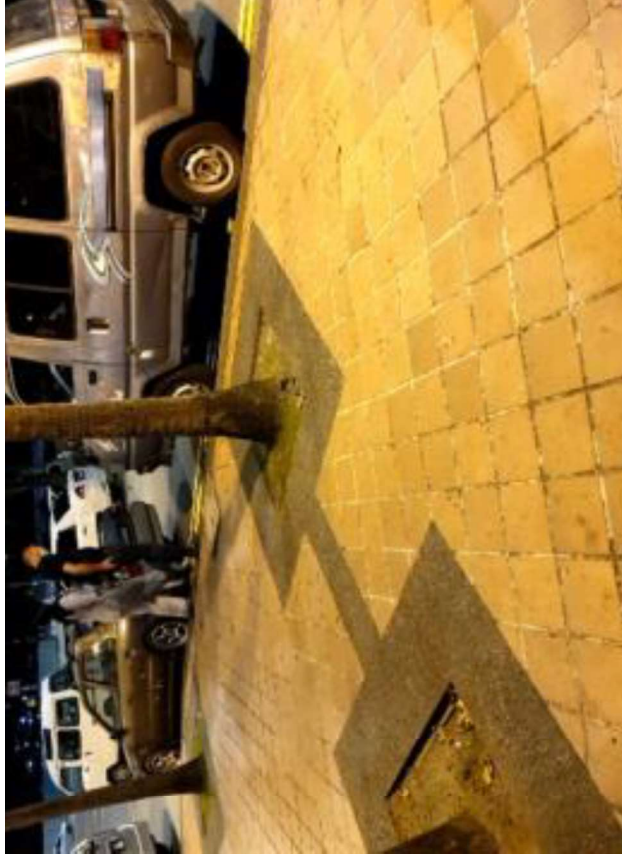
Image 23: Properly constructed pavement around the area for pedestrian walkways

There was a properly constructed pavement in and around the bazaar area. The pavement was elevated, which acted as a divider from the main road. There were no obstructions on the footpath, however some patches were broken and required regular maintenance.

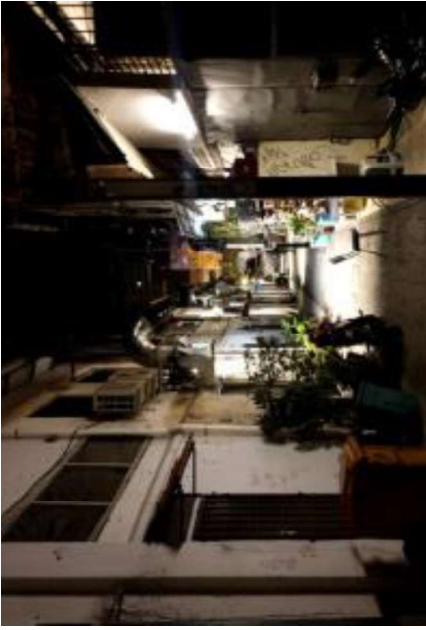
Image 24: The lighting sources were street lights and shop lights but not sufficient to cover the whole area

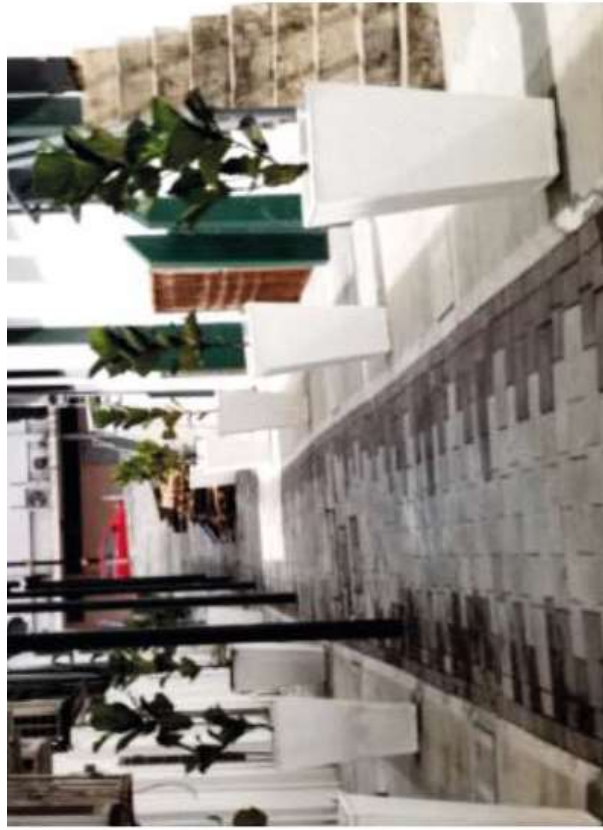
Image 35: The laneway was paved and well-constructed to be used by pedestrian

The laneway was dedicated for pedestrians and was constructed well. In some places, obstructions were found, including debris. There is vegetation around the pavement and there were handrails as well as ramps. It was observed that there was tactile paving and curb ramps to enhance accessibility.

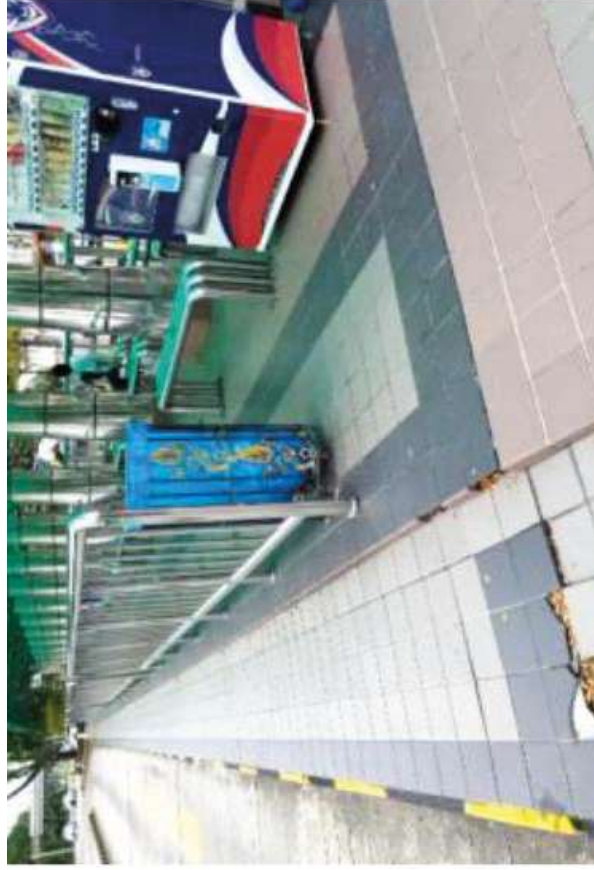
Image 47: There was a trash can and vending machine that leaves minimal clearing space for wheelchair users
