# HOW SAFE IS OUR SPACE?

A PUBLIC SPACE  
SAFETY AUDIT  
OF JOHOR BAHRU

SAFETYPLAN  
Supporting Safer Cities

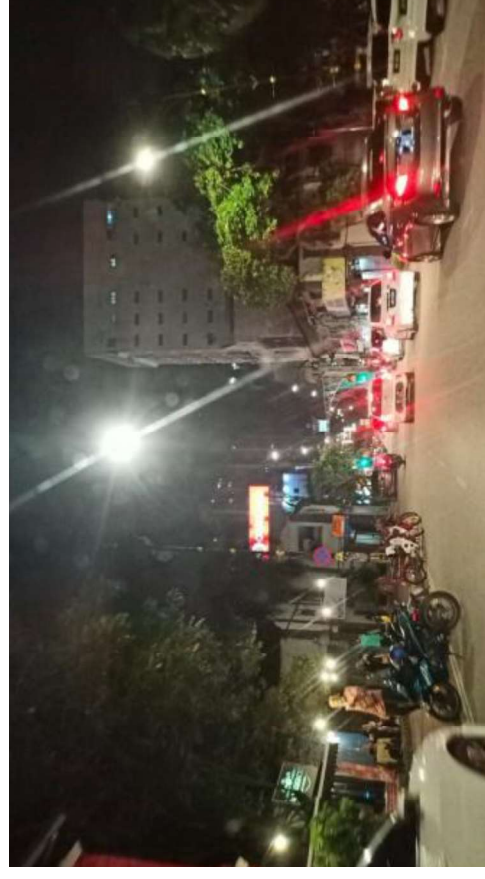
Image 9: Active street with good visibility attributed to shops on both sides of the street

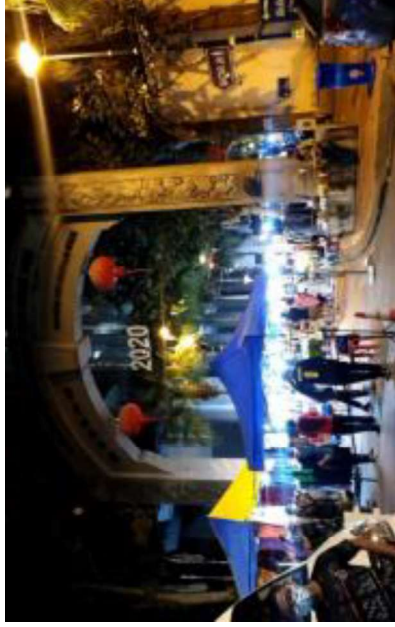
Image 21: The area was occupied by vendors and stalls and well-lit at night

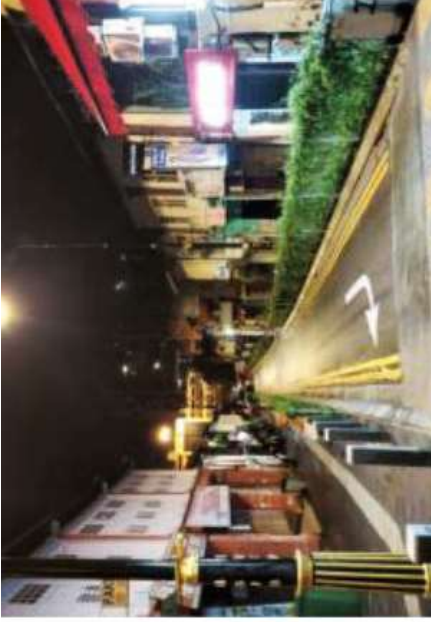
Image 29: The area was well lit at night with adequate amount of street lights

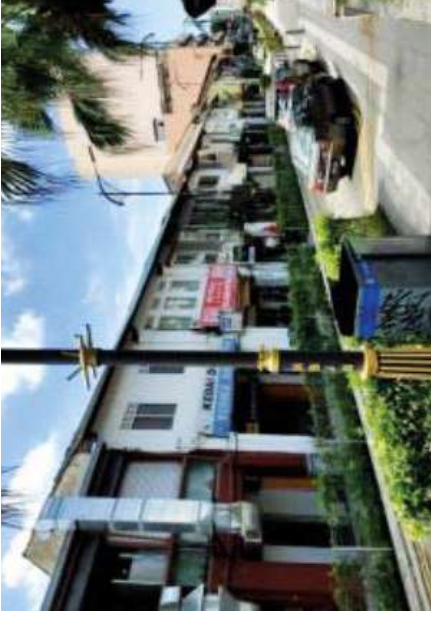
Image 30: The walkway had well-maintained vegetation bed

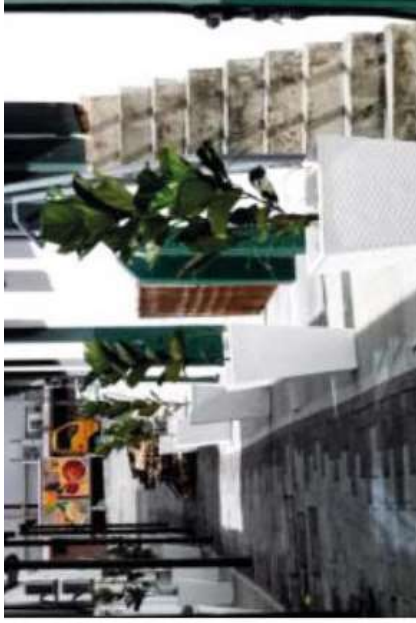
Image 33: The lane was narrow but it extends into an open space so the line of sight was clear

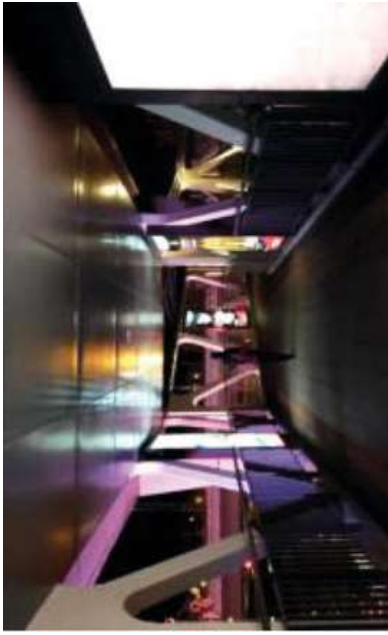
Image 36: The major source of lighting on the bridge were the advertisements boards and the ceiling lights

The major source of lighting on the bridge were the advertisements boards that were set up as accent lighting. There were minimal ceiling lights to illuminate the area at few stretches.

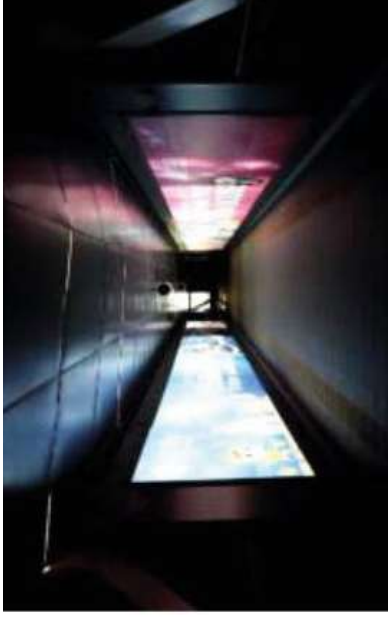
Image 37: The line of sight was obstructed by the advertisement boards at some stretches

When placed on both side of the bridge, the boards act as a barrier between the pedestrians and the surroundings below. At times when the lighting fixtures were not functional or poorly lit, as seen during the audit, the space becomes unsafe with no clear line of sight. Therefore, should be uniformly lit using ceiling lights and advertisement boards spread around the area so that there is some visual connection with the built environment.

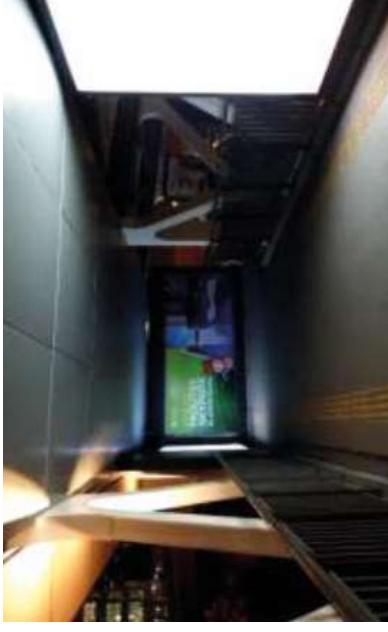
Image 38: No vegetation was spotted around the bridge

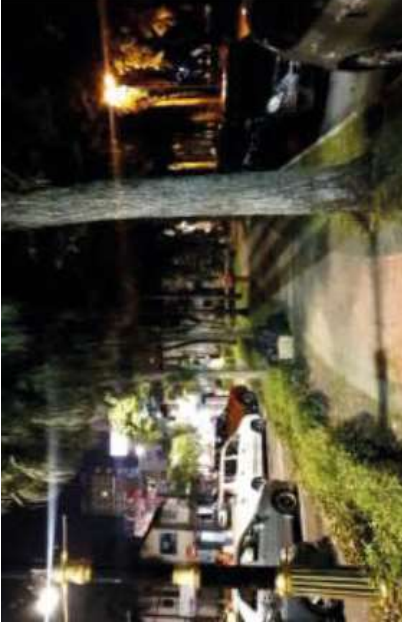
Image 42: The trees shaded some of the footpath acted as natural cover at some stretches

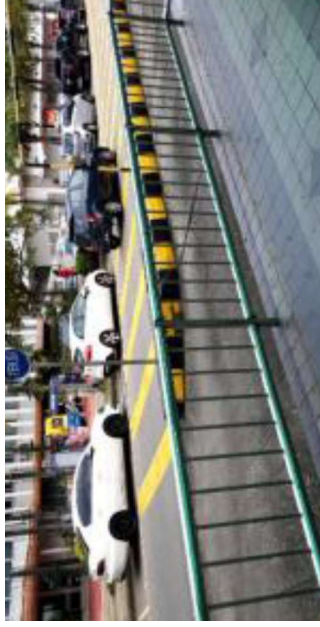
Image 45: The bus stop was located in an open area providing a clear line of sight
