# HOW SAFE IS OUR SPACE?

A PUBLIC SPACE  
SAFETY AUDIT  
OF JOHOR BAHRU

SAFETYPLAN  
Supporting Safer Cities

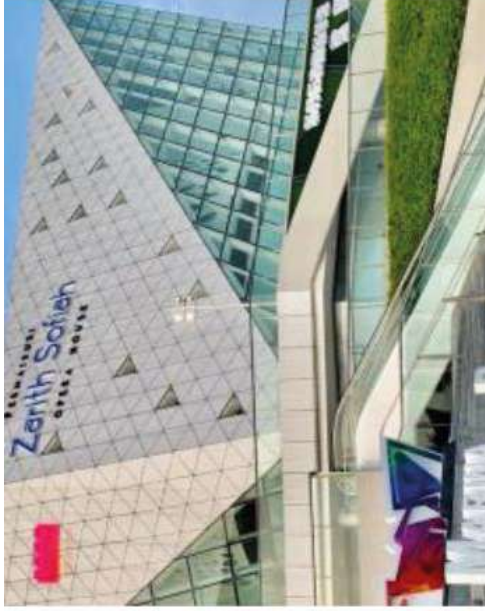
Image 13: In front of the Opera House was an open area

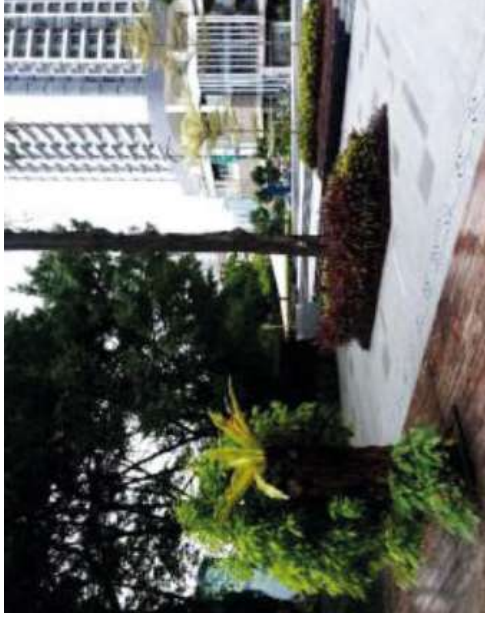
Image 14: The Opera House had an ample and well-maintained vegetation coverage

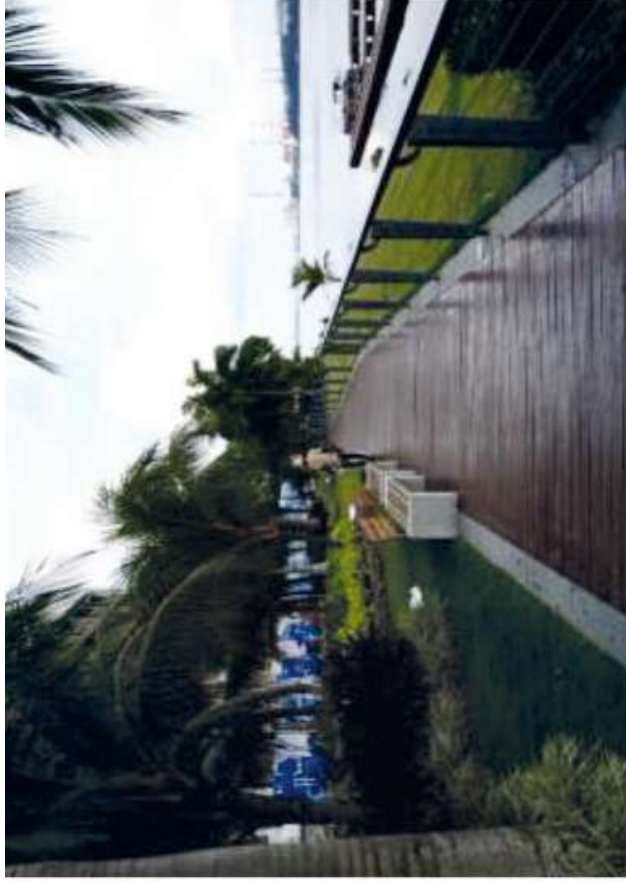
Image 15: The promenade along the Opera House was well-maintained and guarded by fences

Owing to its location, Permaisuri Zarith Sofiah House was not easily-accessible for public transport users or pedestrians. While the promenade was well-developed along the Johor Strait, it was poorly lit and not active, hence creating an unsafe perception at night-time. A cycle path could be developed around this area which would help the visitors avoid private transport and increase the activity along the promenade.

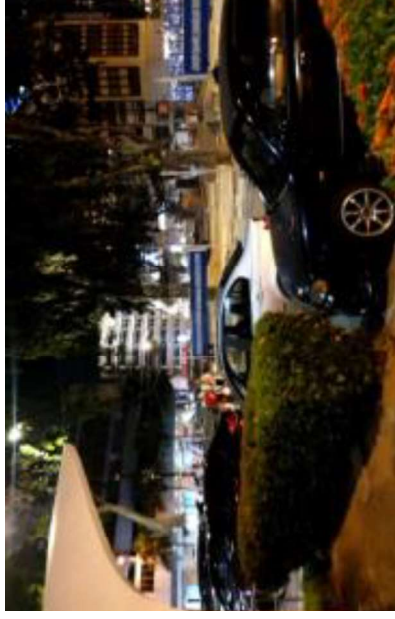
Image 22: Vegetation were mostly spotted outside the area

There were some trees and bushes outside the market area, near the parking. However, inside the bazaar, there was poor to little vegetation.

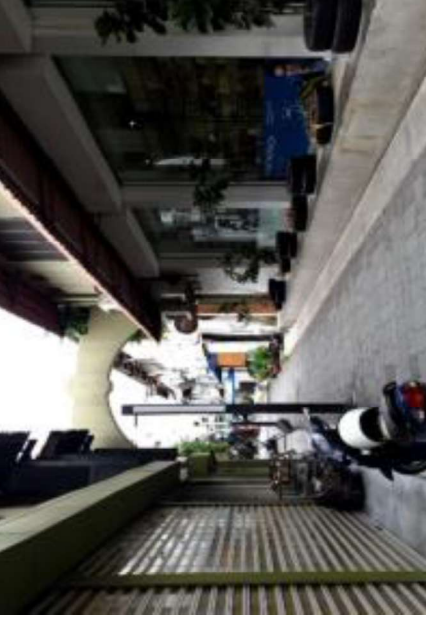
Image 25: The lane was narrow for vehicles but not for pedestrian

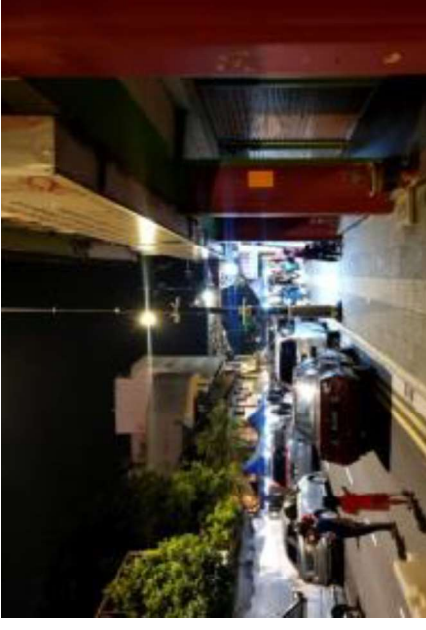
Image 26: Limited vegetation was recorded in the form of planters and pots

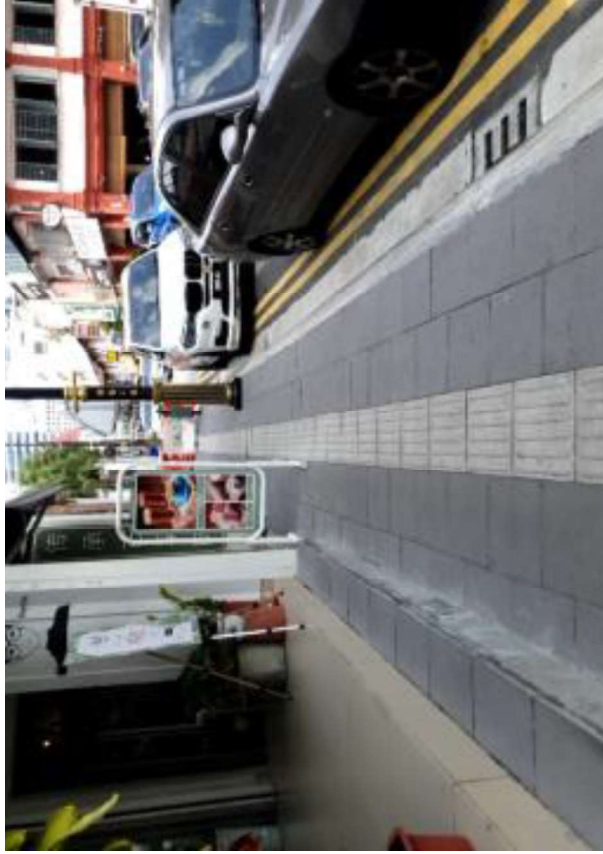
Image 27: The path was paved and had tactile paving

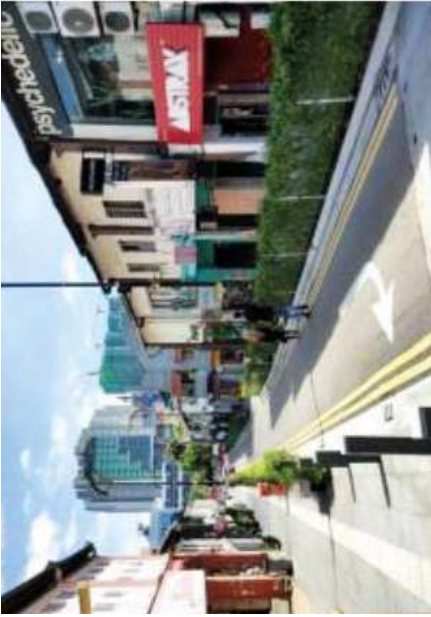
Image 28: The openness of the area was good with a clear line of sight

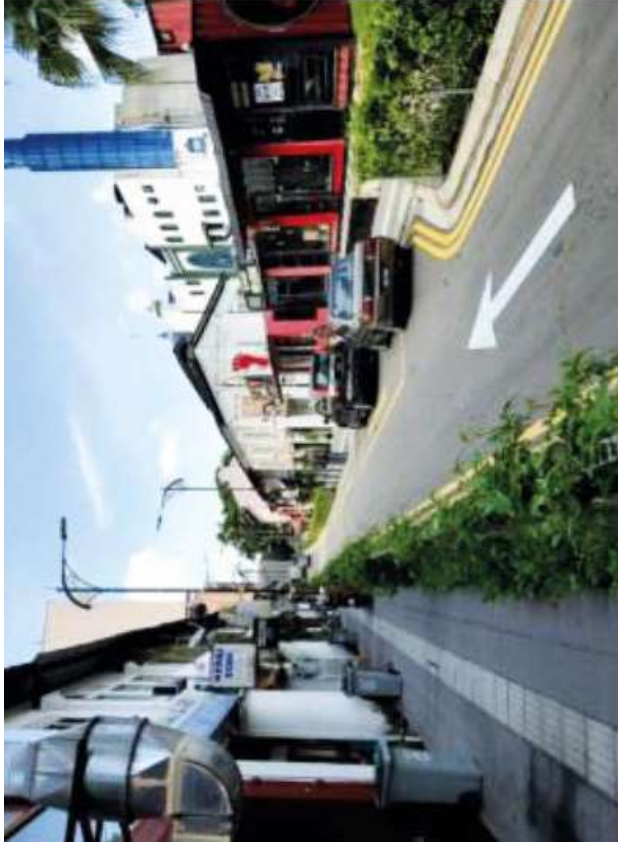
Image 31: The pavement had tactile paving, curb ramps, and at-grade pedestrian crossing

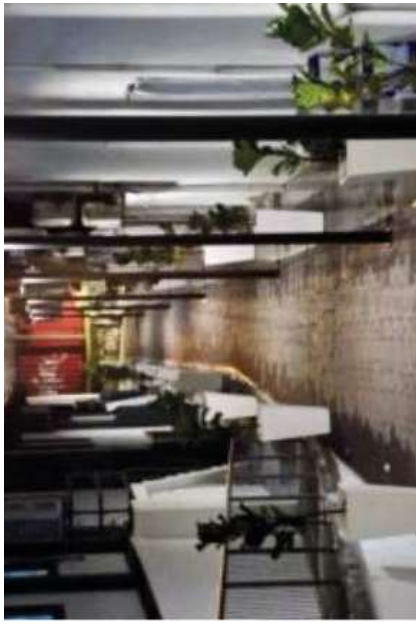
Image 32: The lane was well-lit at night with various source of lightings

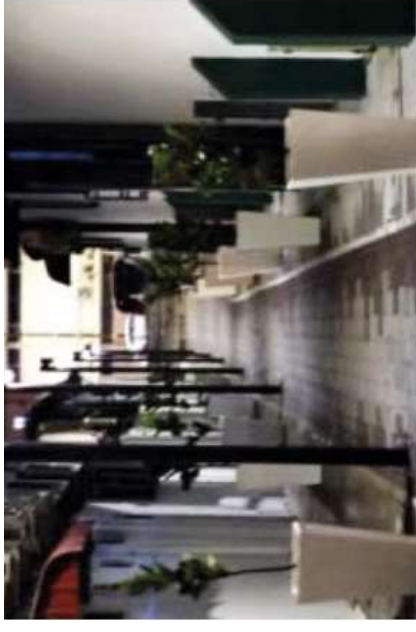
Image 34: Planters were placed along the lane

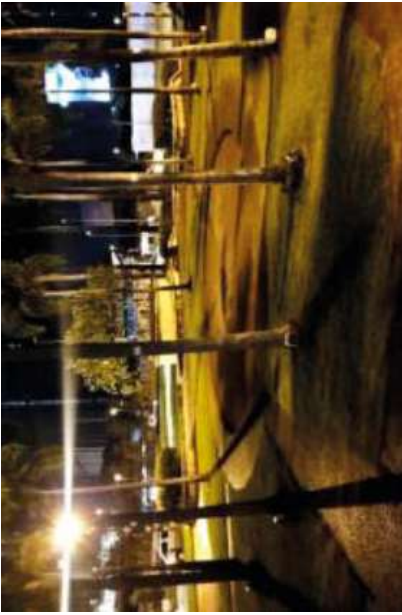
Image 40: The area were dimly lit during night due to non-functional street lights

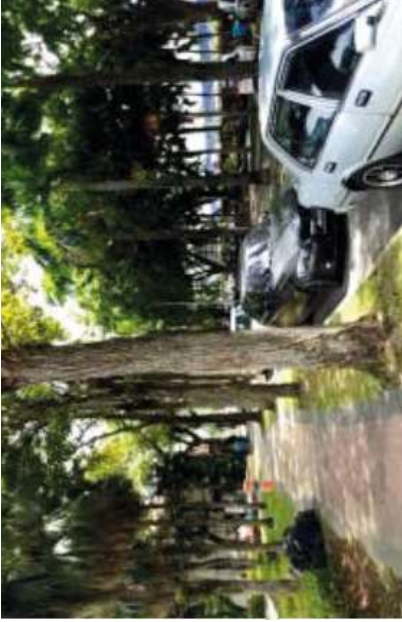
Image 41: There were trees, bushes and shrubs all around the park

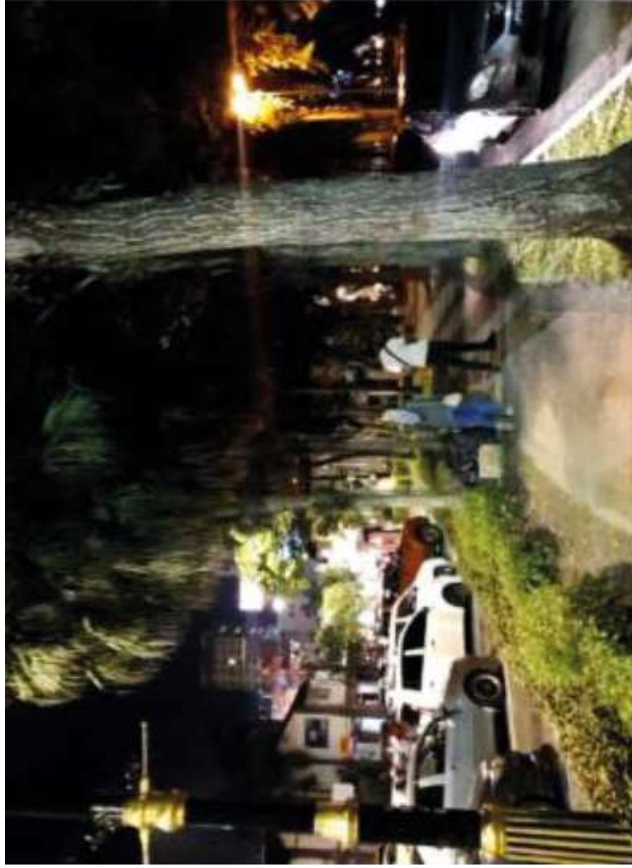
Image 42: The trees shaded some of the footpath acted as natural cover at some stretches

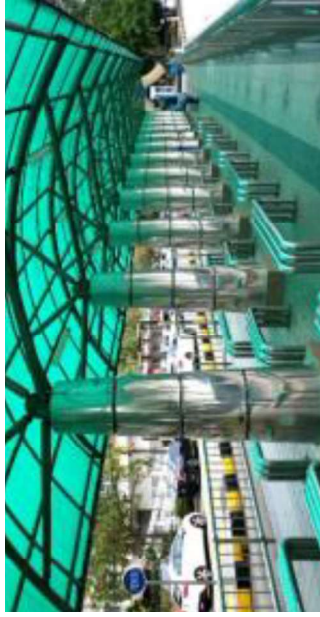
Image 44: The bus stop was well-equipped with proper amenities

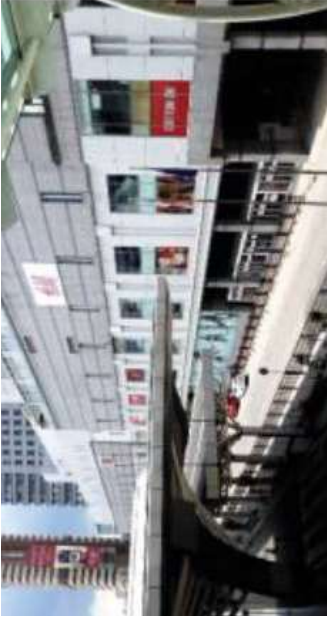
Image 48: JB Sentral was located opposite to a mall hence the area were quite open to move and see around

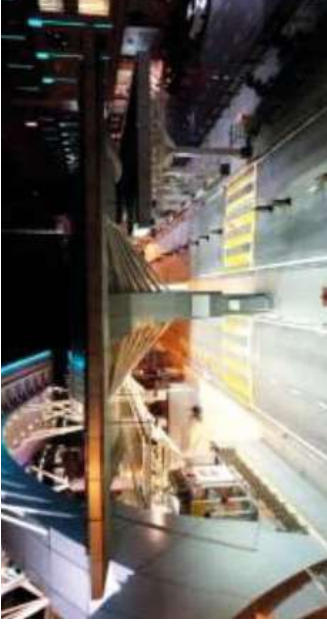
Image 49: The terminal was well-lit with sufficient lightings from the building as well as the street lights

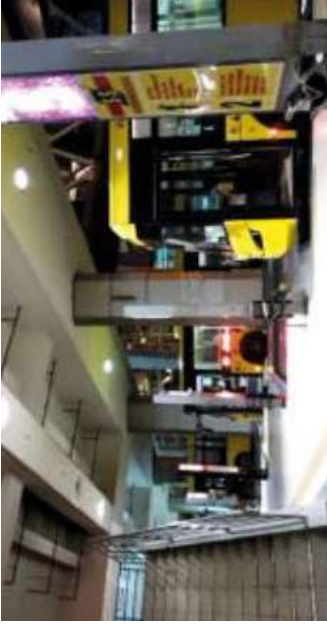
Image 50: There were a proper buses zone with surveillance system

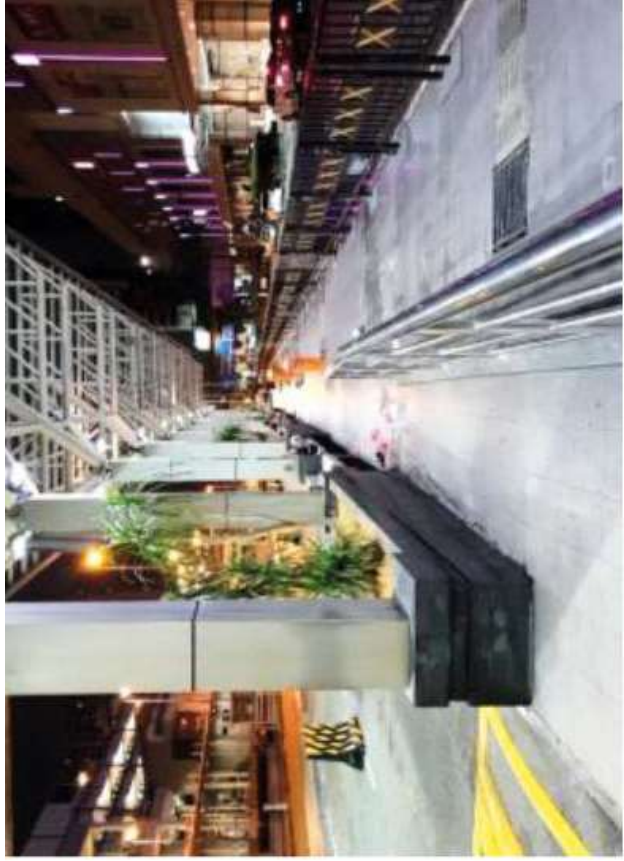
**Image 51:** The pavement leading to the terminal was elevated, had shade, fences, and vegetation beds at some stretches

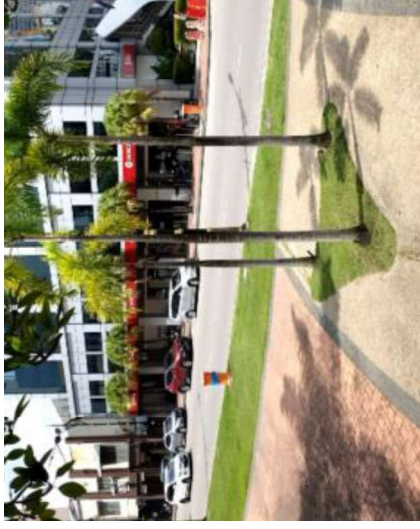
Image 58: Main street outside the park

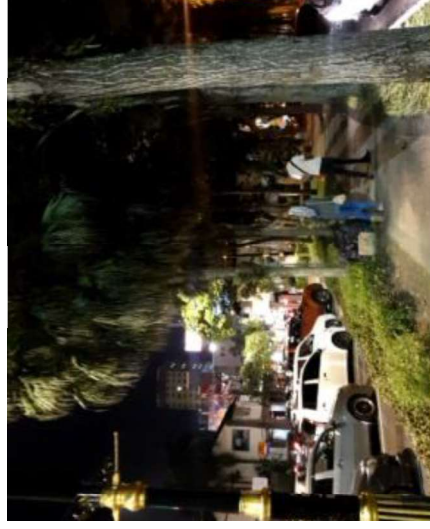
Image 60: Walk path in Laman Tun Sri Lanang Park

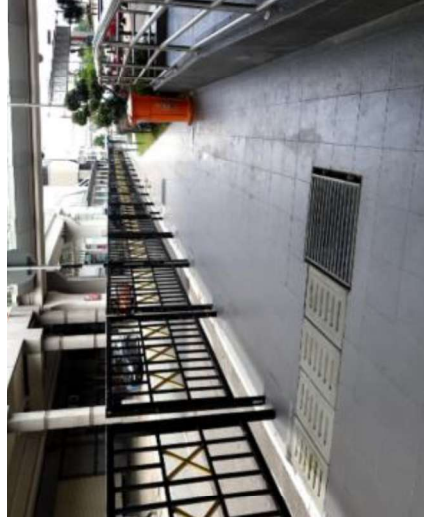
Image 62: Walk path at JB Sentral in the day

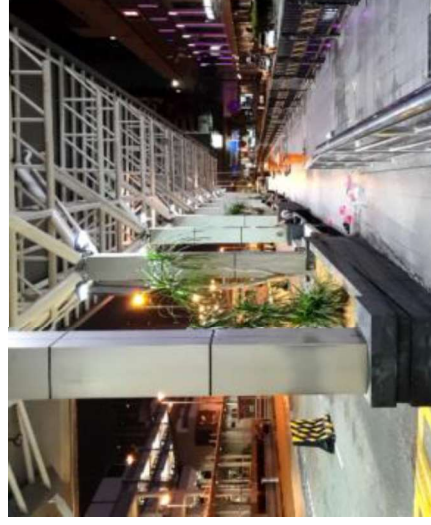
Image 64: Walk path at JB Sentral at nighttime
